Condition Assessment & Reserve Fund Plan FY2015

Mt. Woodley Manor

Alexandria, Virginia

RE: **CONDITION ASSESSMENT AND RESERVE FUND PLAN FY2015**
Mt. Woodley Manor Homeowners Association
Alexandria, Virginia
Project No. 7626

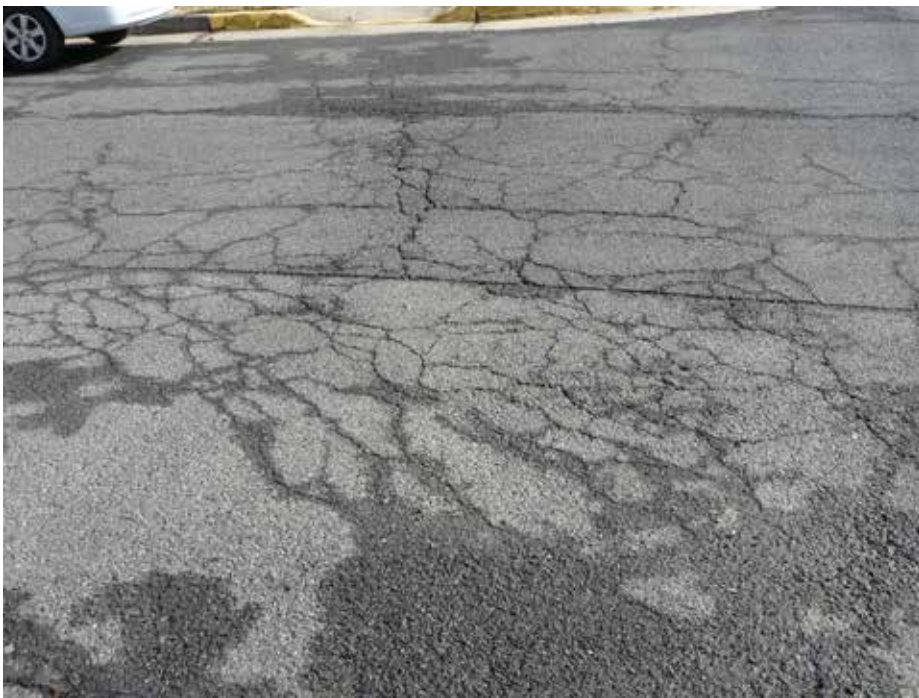
PHOTO #1

The asphalt driveways and parking bays are in poor condition. It does not appear that any crack filling or seal coating has been accomplished since restoration circa 1995.

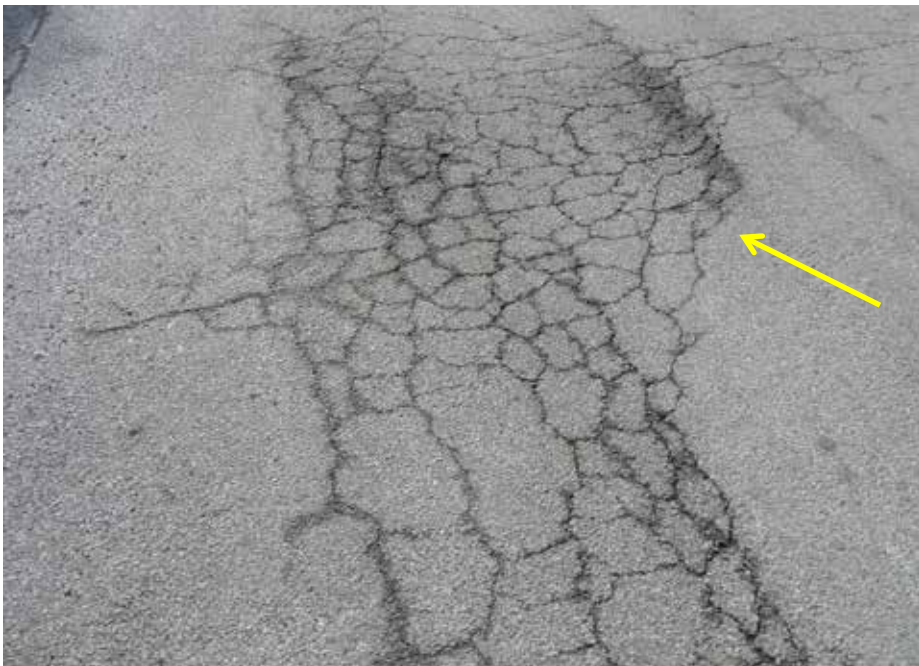
PHOTO #2

A significant amount of alligator or deflected cracking (indicative of sub-base damage) was observed.

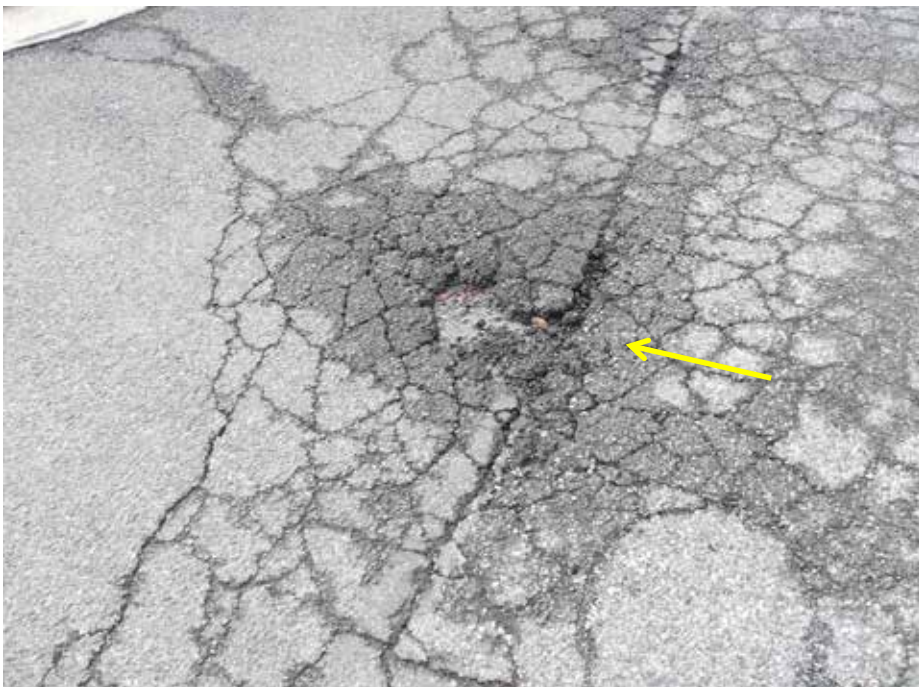
PHOTO #3

A few areas of delamination were also observed, which will continue to worsen as the pavement ages.

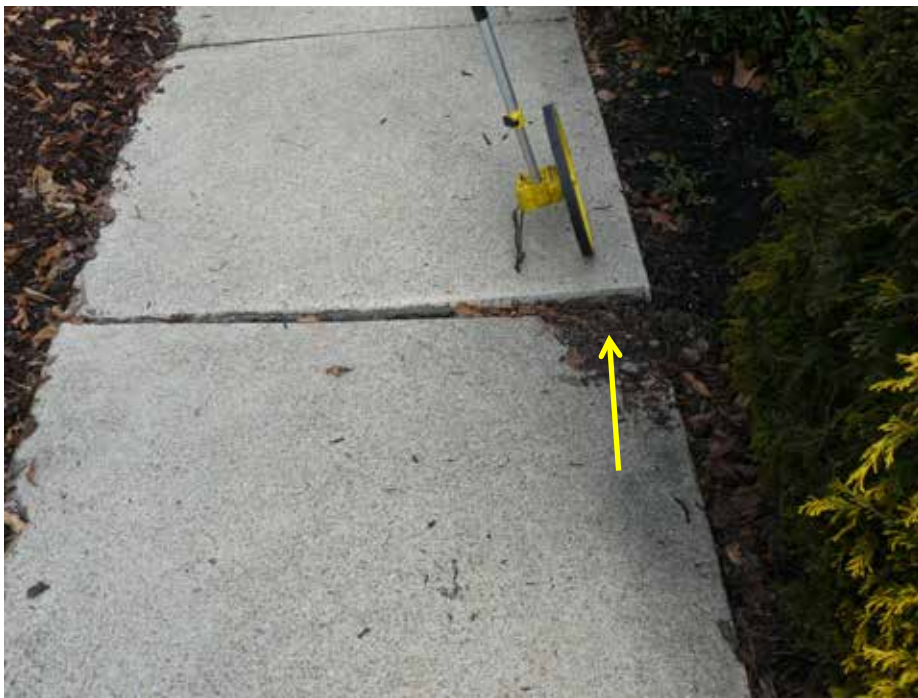
PHOTO #4

Although some sections of concrete sidewalk have had cyclic repair, other sections, such as this settled area require repair, as these are potential tripping hazards.

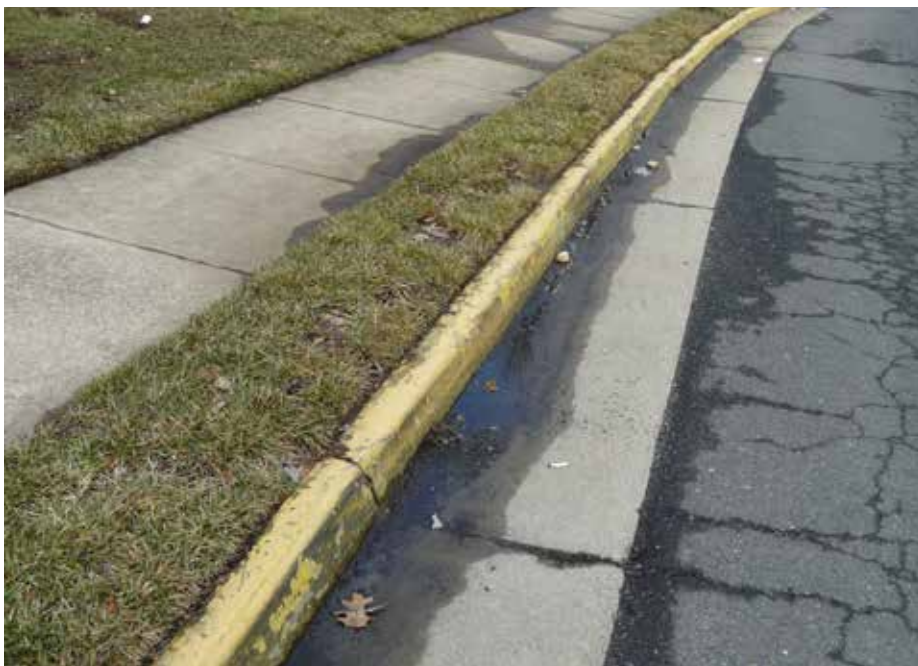
PHOTO #5

A majority of the concrete curbs and gutters are in good condition. Some settled sections were observed and require cyclic repairs.

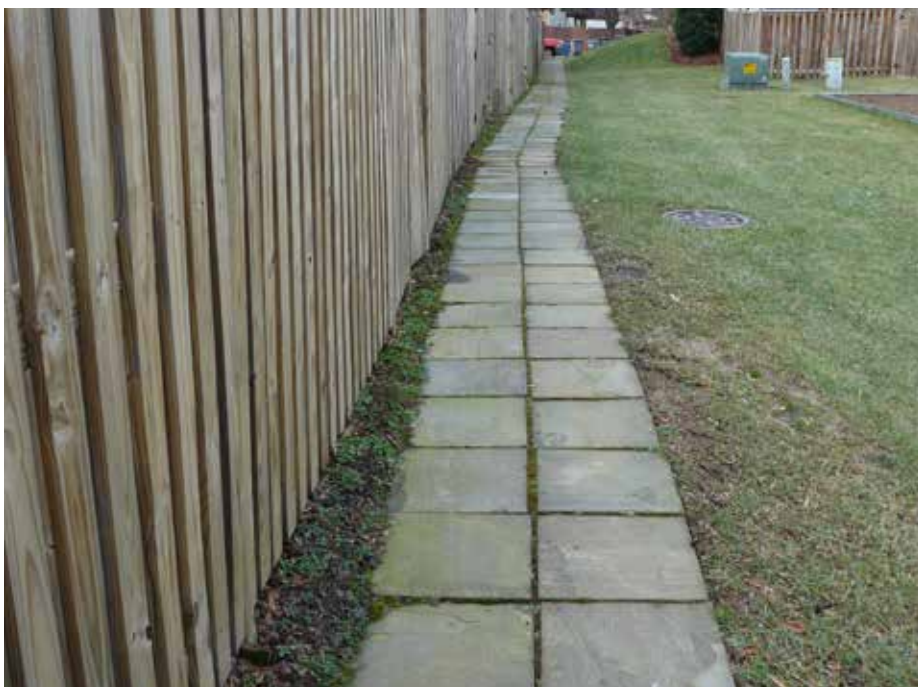
PHOTO #6

A majority of the walkway pavers are also in good condition. About 10% of the pavers were cracked, settled, or heaved. The pavers with differential heights are potential tripping hazards, which should receive near-term replacement or rebedding.

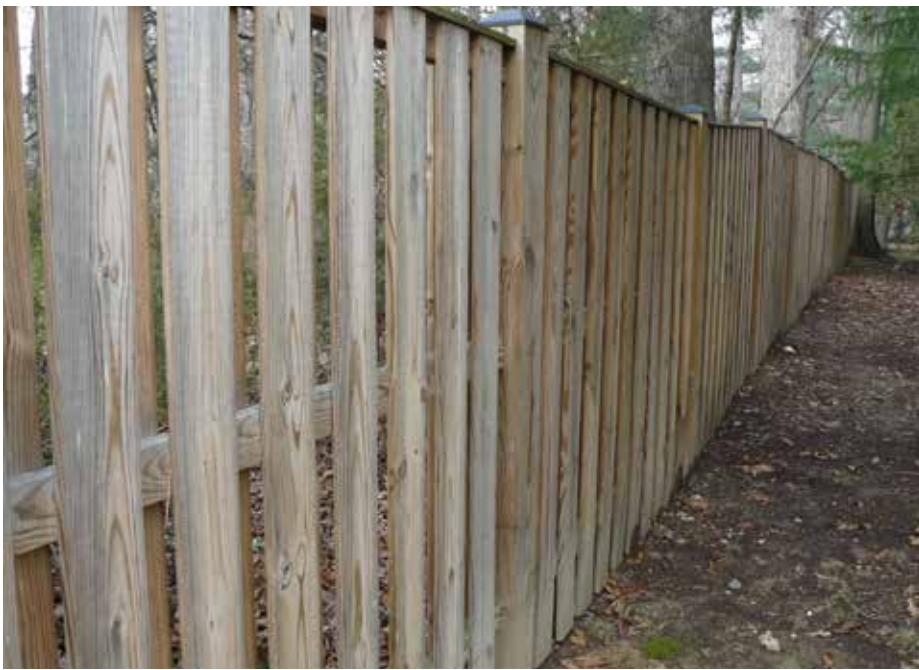
PHOTO #7
The wood fencing is in good condition. Staining/sealing of the wood will help to extend the service life.

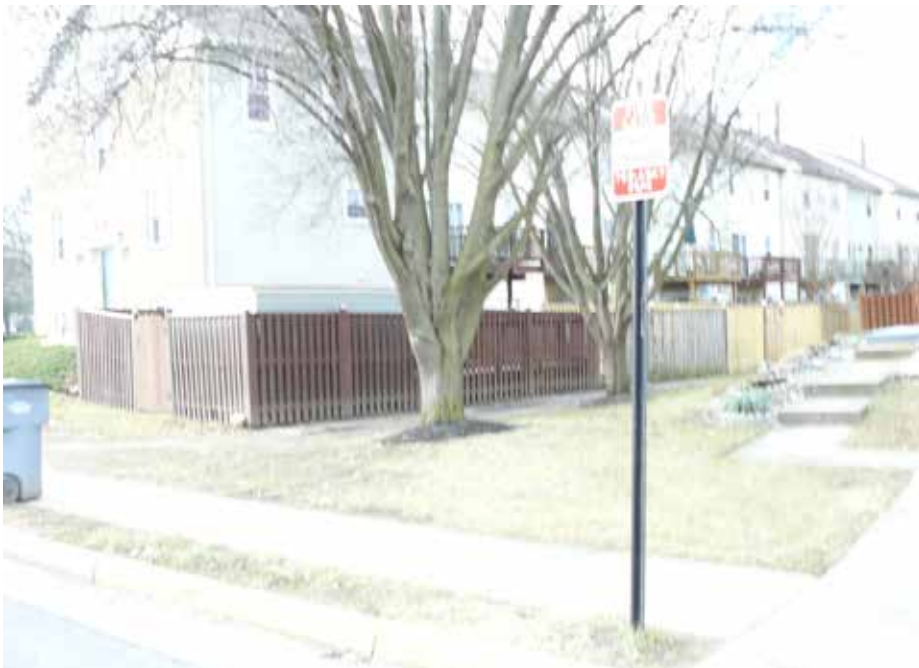
PHOTO #8
Most street signage is in good condition.

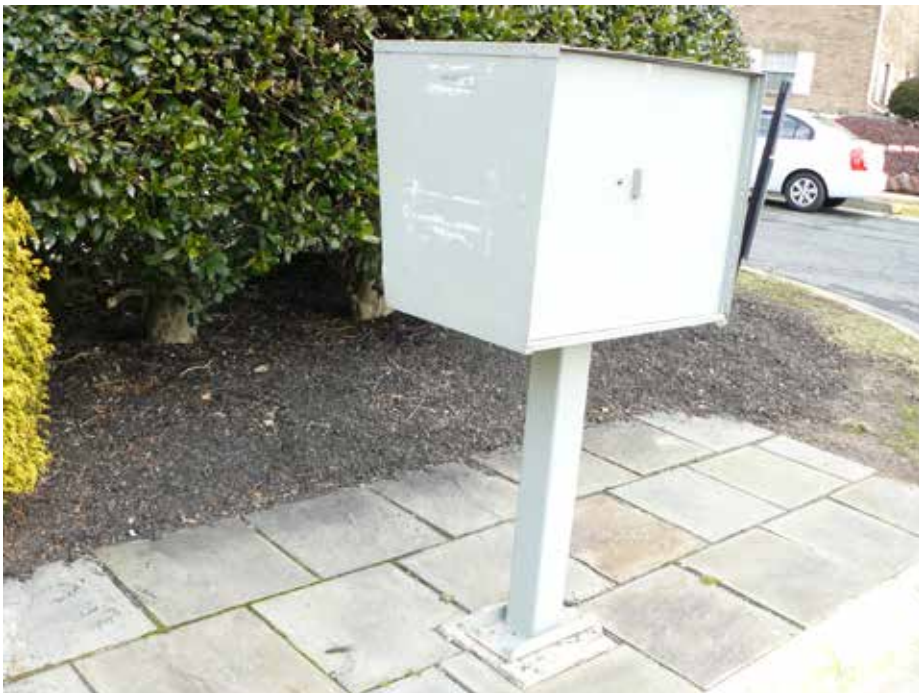
PHOTO #9
The mailbox modules are in fair condition. Eventual repainting of the modules will help to extend their service lives.

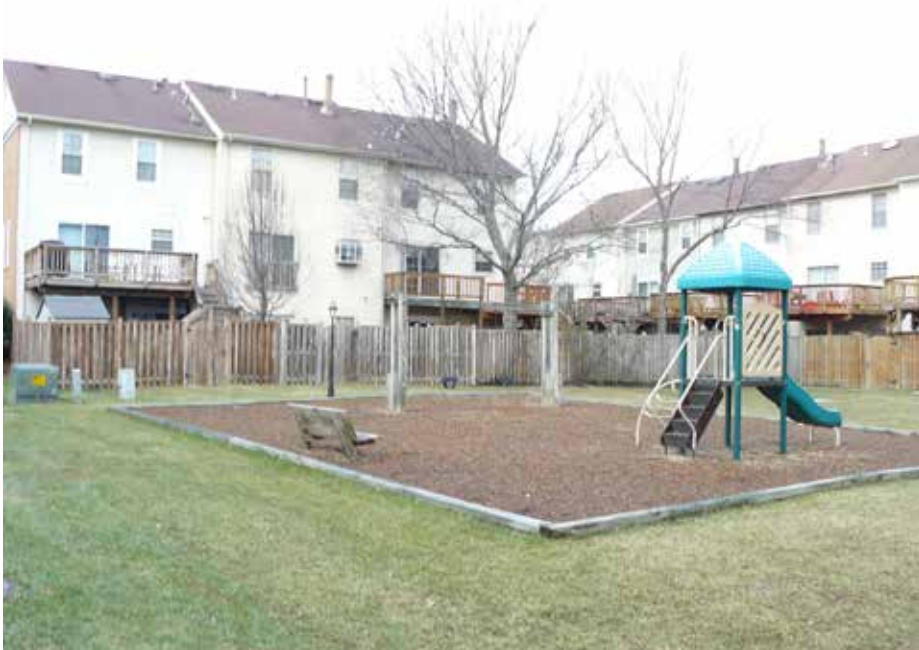
PHOTO #10
The tot lot #1 components are in fair condition. Pressure washing the play modules will help to improve appearance.

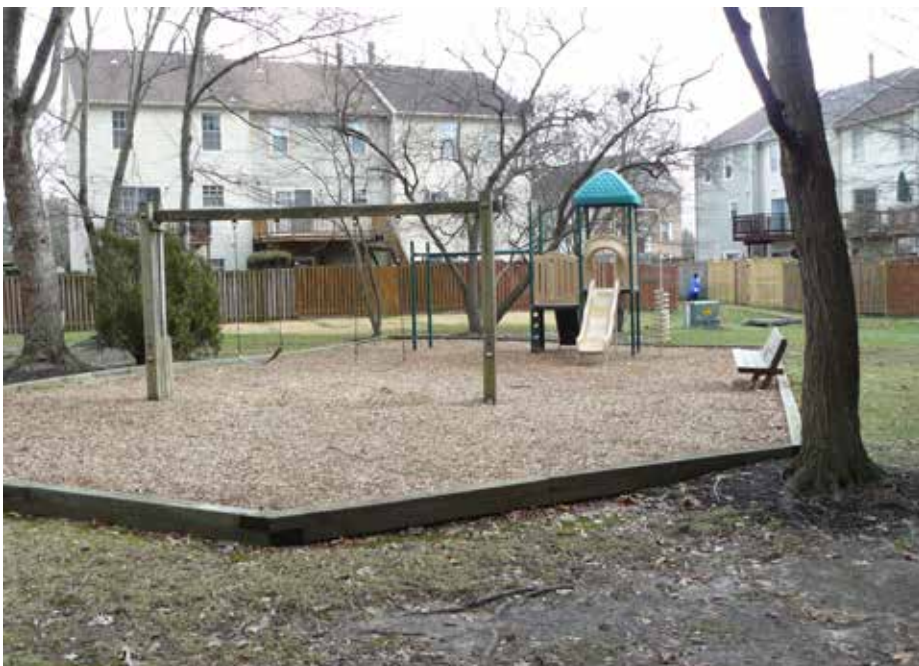
PHOTO #11
The components at tot lot #2 are also in fair condition. The play equipment should be regularly monitored for safety.

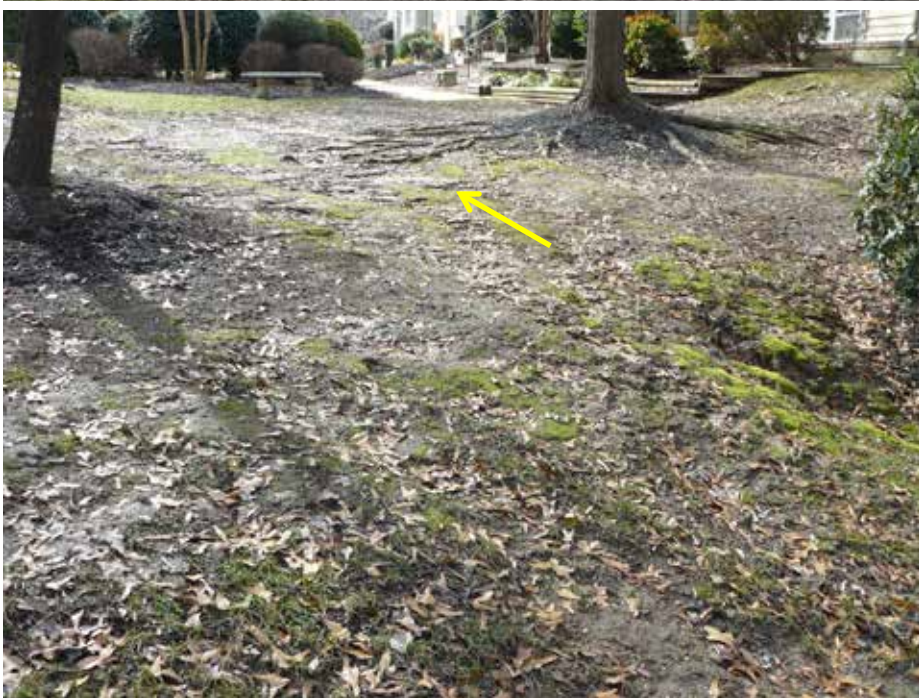
PHOTO #12
Some areas of erosion were identified, which can be repaired under the Storm Water Drainage System Allowance.
